## 6.2 Richfield Fire Protection District

### 6.2a Fire, Structural, and Community Assessment for Richfield FPD

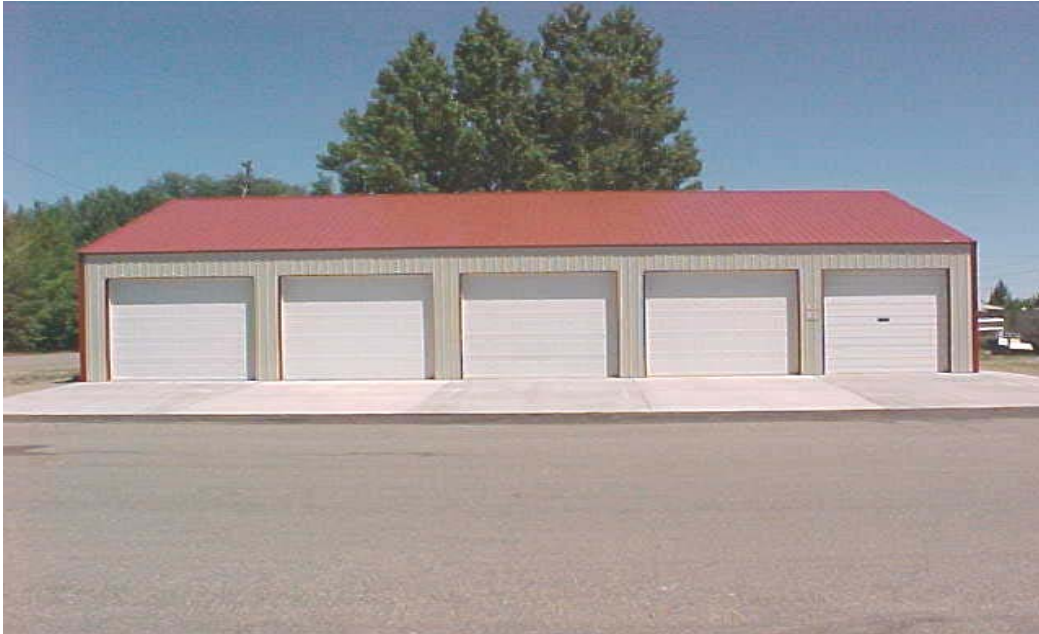
**Figure 10: Richfield Fire Station, 2004**

The new facility has no restroom; no changing room; no office or training space, no storage space, and a gravel floor. Upgrade, or improve upon the new facility is one of the Richfield Fire Department’s top equipment infrastructure priorities. Estimated upgrade costs are included in the budget spreadsheet. (Appendix D)

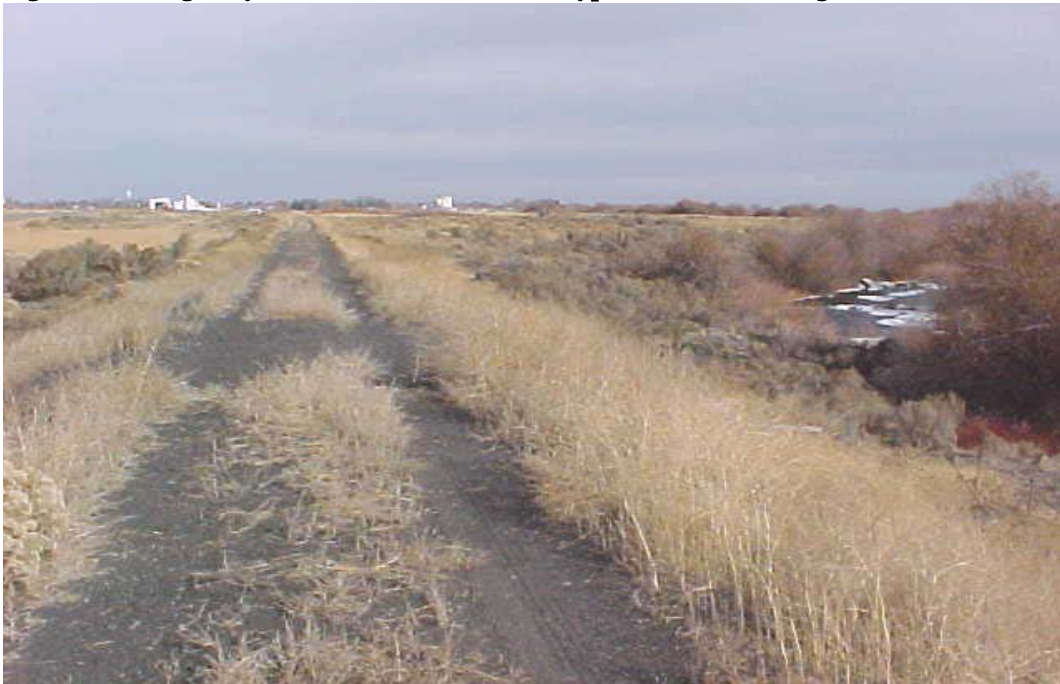
**Figure 11: Highway 93/old UPRR ROW Typical Fuel Loading Richfield FPD**
